Property Condition Assessment

Property Address: 000 Sample Dr.
TX

Report Number: 20170601-03

Commercial Sample Report

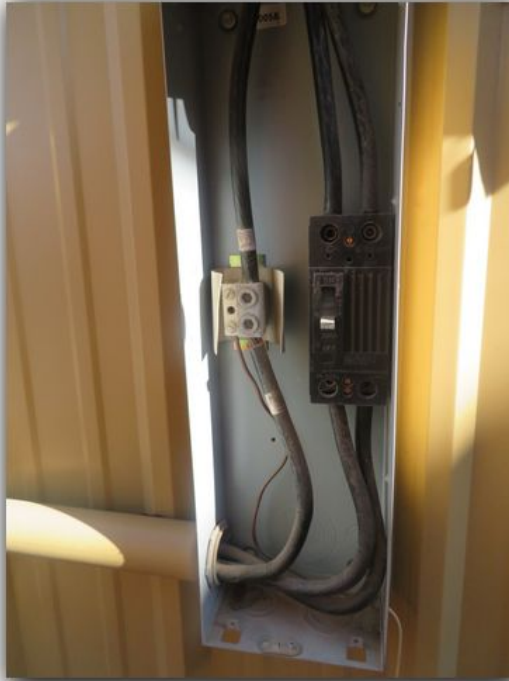
Exterior panel at the left did not provide an inner panel. Safety issue

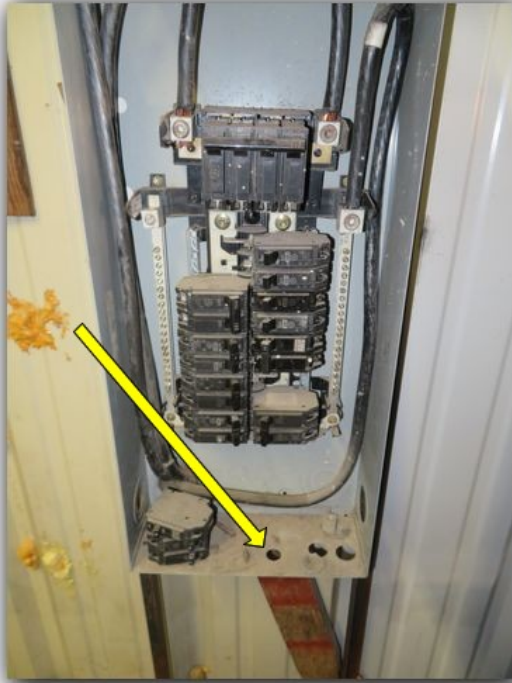
The interior panel at the right also did not provide an inner panel. Seal the knock outs at the bottom of the panel. Safety issues

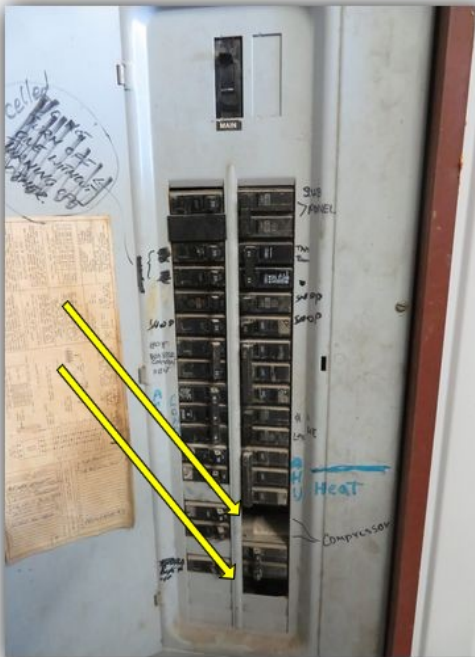
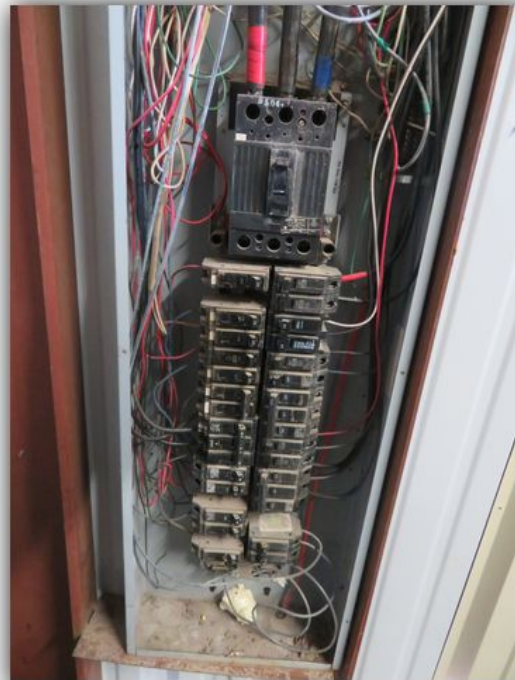
Far left panel has knock outs that need to be sealed and missing knock out strips on the inner panel.

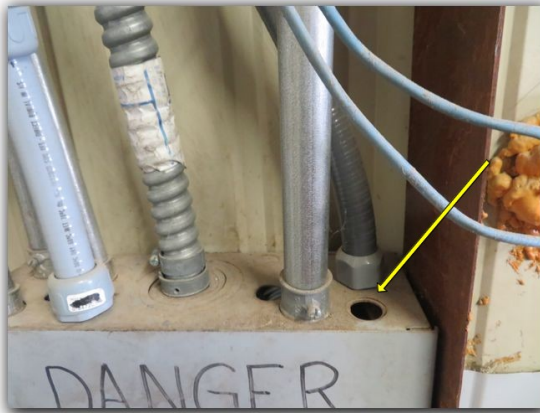
Seal the knock outs at the top of the panel. Safety issue

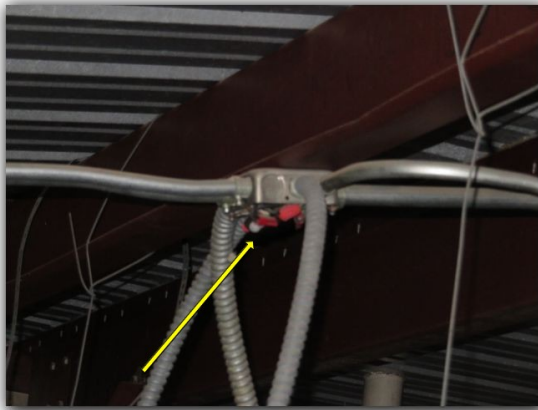
Open J-box cover above the attic area of the office. Needs a cover.

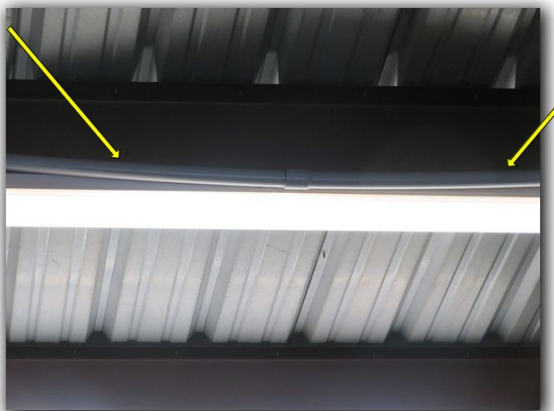
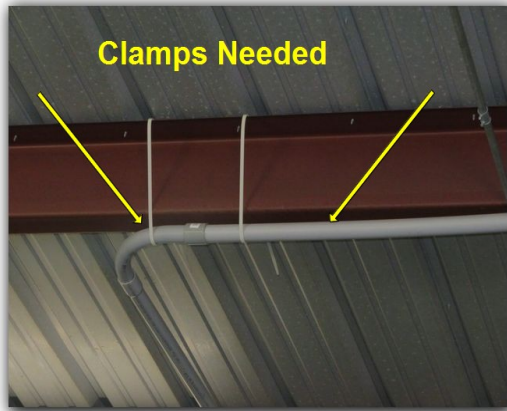
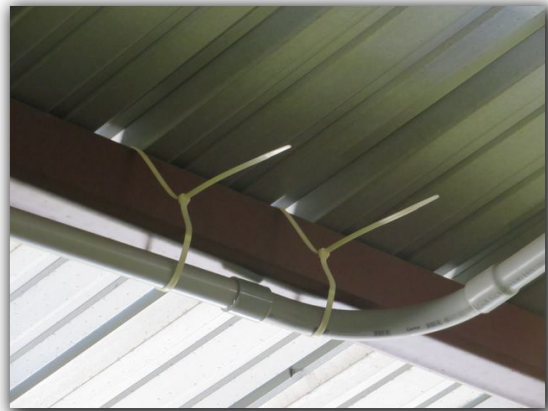
RNM conduit should be clamped every 10 feet or 3 feet from a coupling. Several clamps are missing and some strapping used in place at the 90. The conduit is sagging at one section.

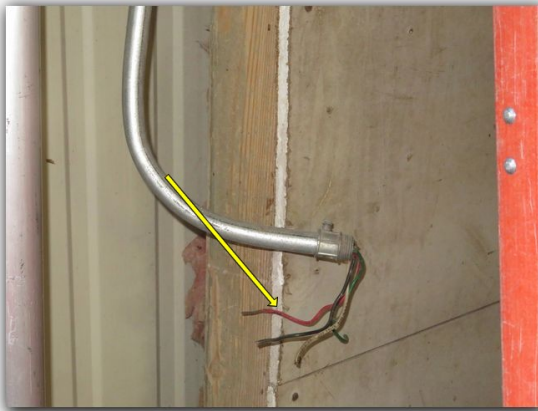
Terminated conduit with wires are present at the rear bay door. Recommend removal or tapping/capping the ends of the wires.

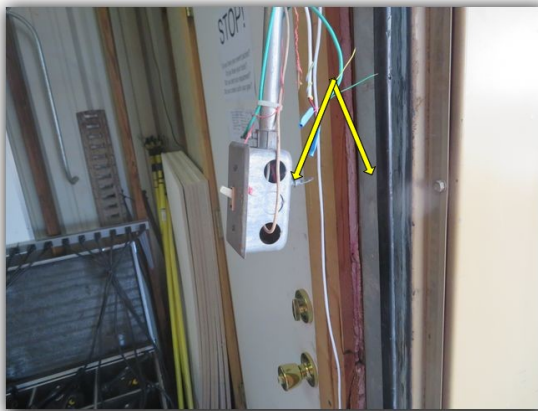
Light switch at the rear bay door is not secured to the structure

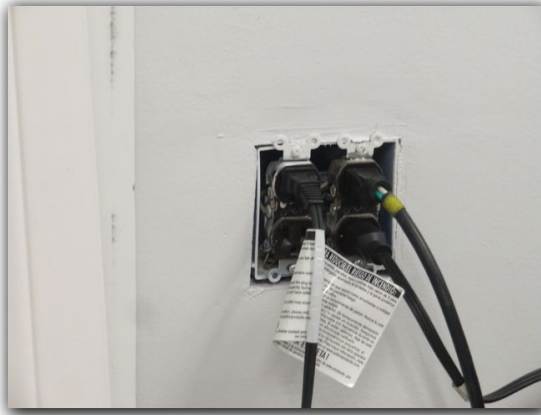
Numerous outlet covers are off in the offices, tenants are in process of installing.

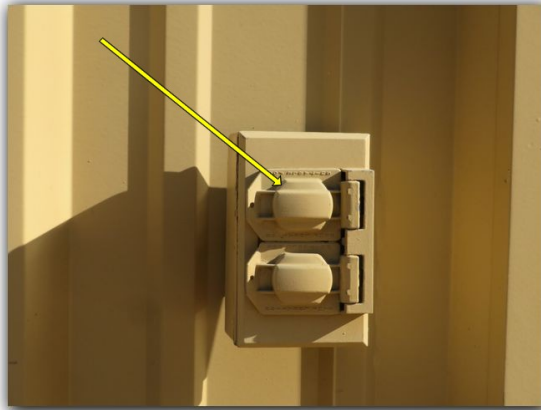
No GFCI protection at the exterior outlet at the rear of the building.

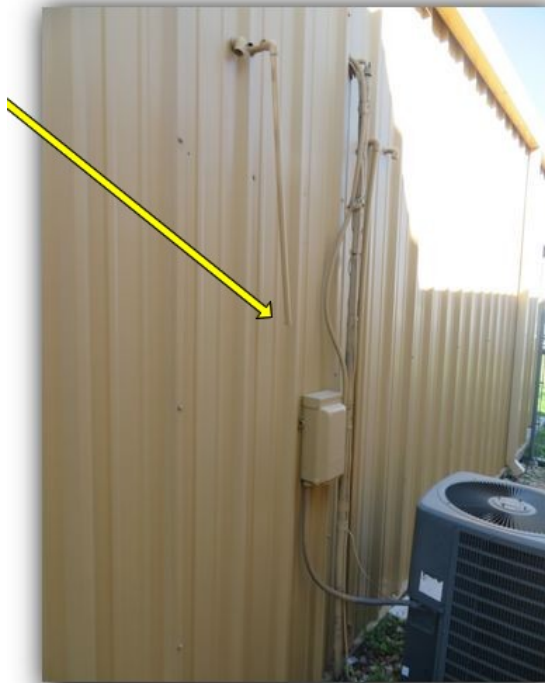
Water heater temperature pressure line should have been terminated at min. 6 inches off the ground at the left side of the building.

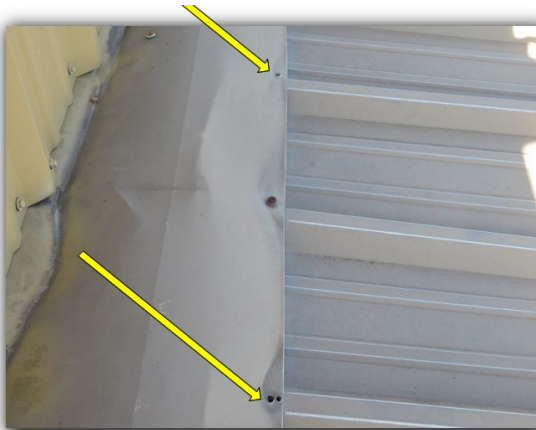
There was some flashing at the front porch cover that has some of the screws missing to secure it.

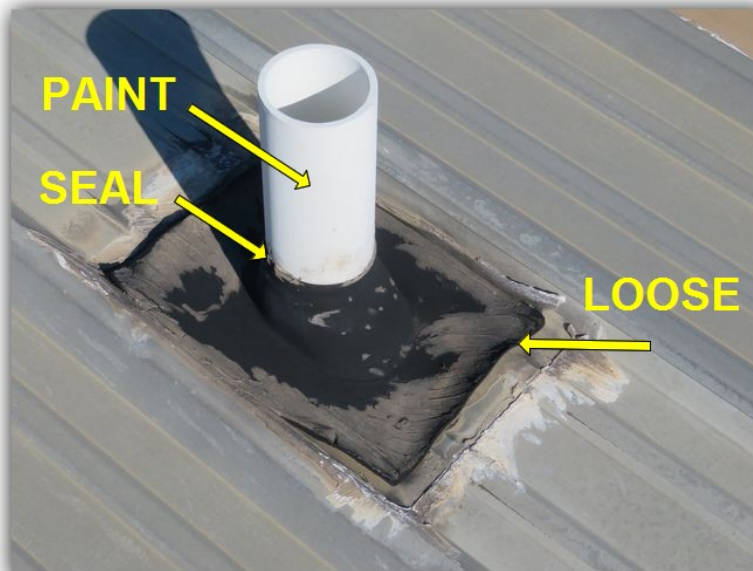
The air stack vent was not painted to provide uv protection and the rubber boots appears to be shrinking and not sealed properly.

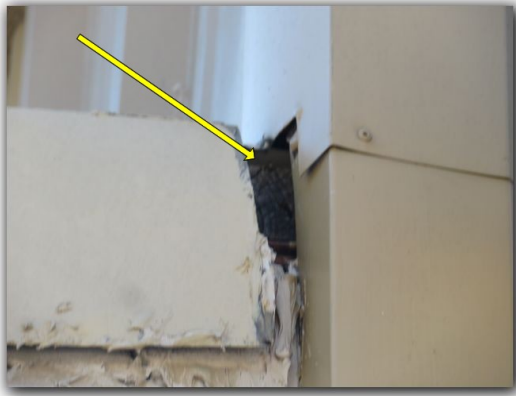
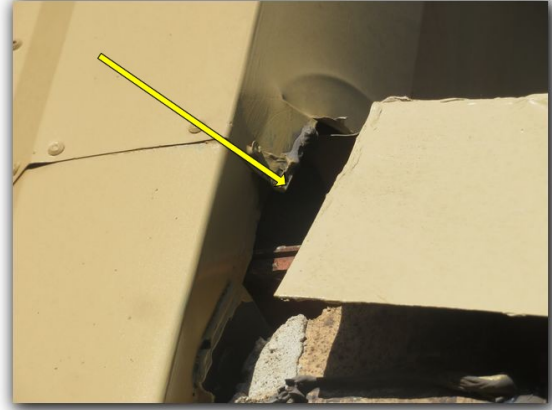
Ends of the front porch have open ends that water can penetrate. Seal off at both ends needed.

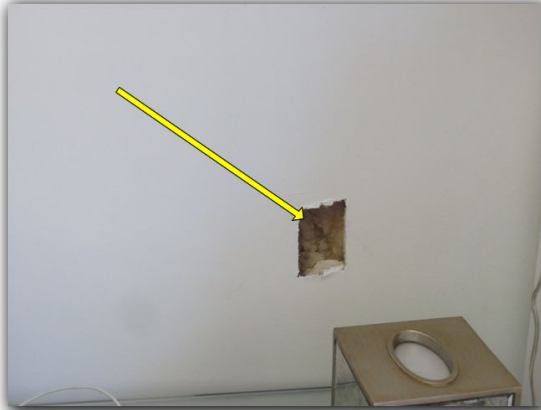
Right rear office has one cutout that needs to be sealed up. Small holes at the plumbing area under the bathroom vanity need sealing too.

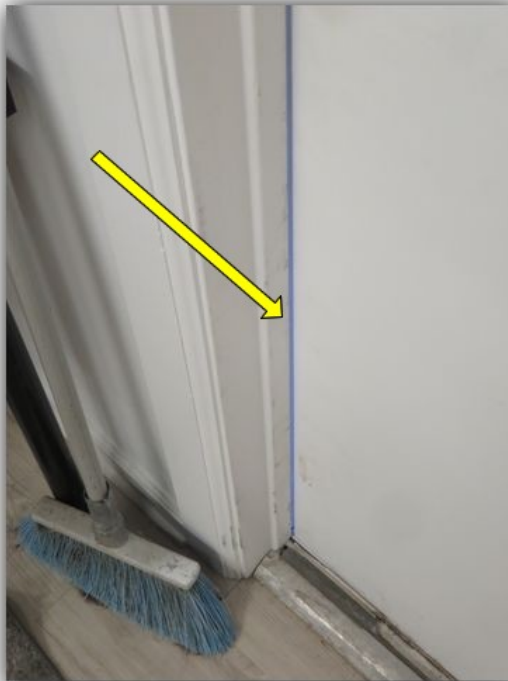
Shop exit door is not sealed off well and lets conditioned air escape along the side.

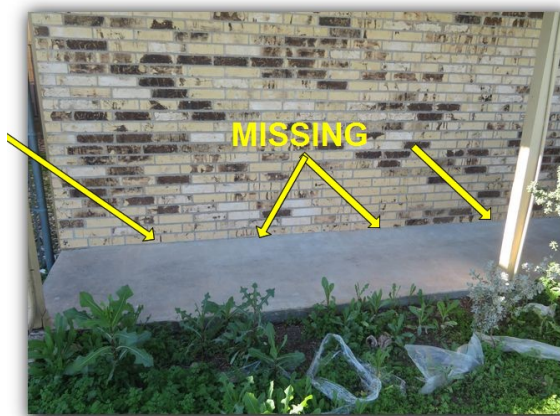
Front brick wall has some of the weep holes sealed up. They should be installed every 3 feet to release condensation that can accumulate behind the walls.

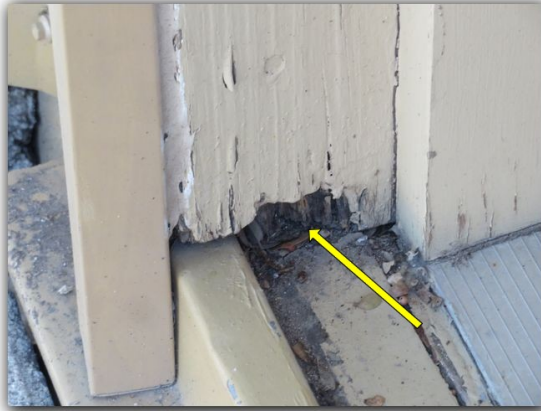
Rear single door has some wood rot starting at the sides.

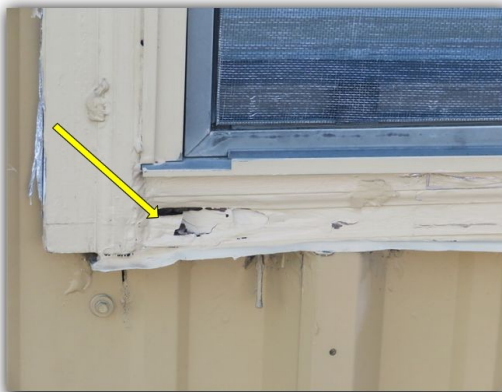
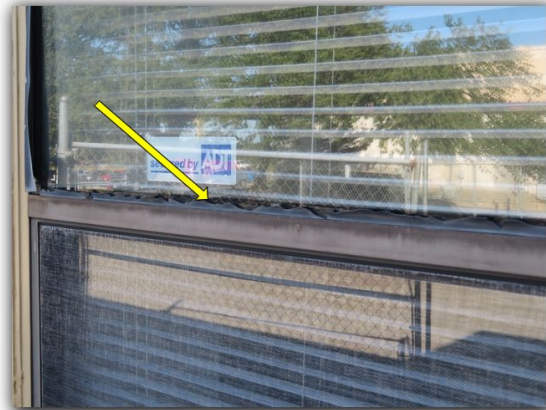
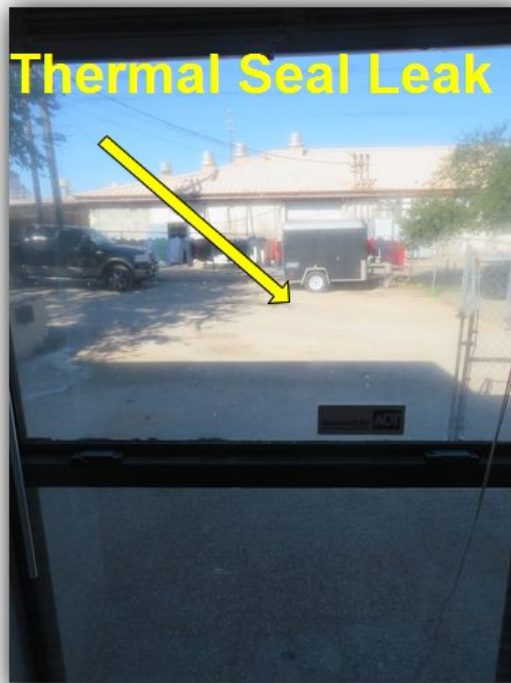
Right side office window has wood rot at the trim, thermal seal leak at the top window and the glazing strip beaten up.

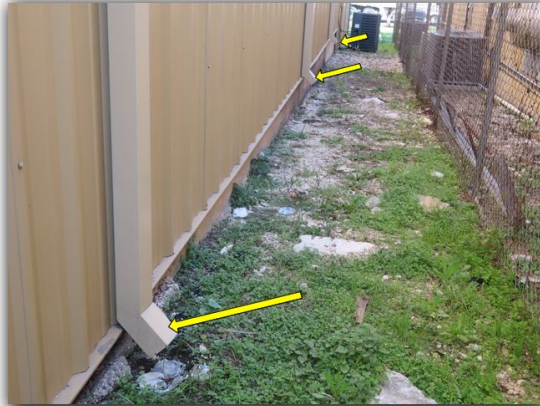
Drainage- gutters at the left side would benefit with extensions to keep water from dropping next to the slab and causing erosion.

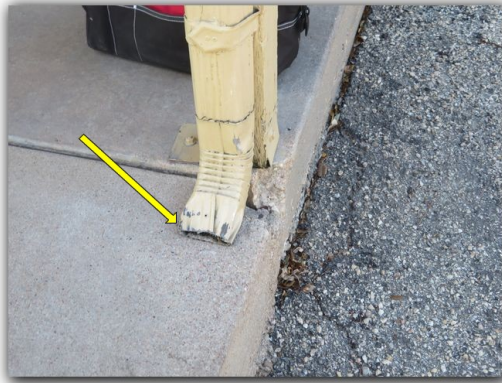
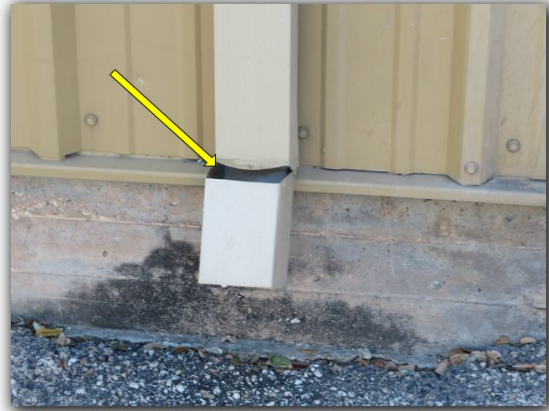
Front porch down spout is crimped and the diverter at the right is loose.
